TEST REPORT

No. : XMIN2102001299CM

Flooring, See the photographs.

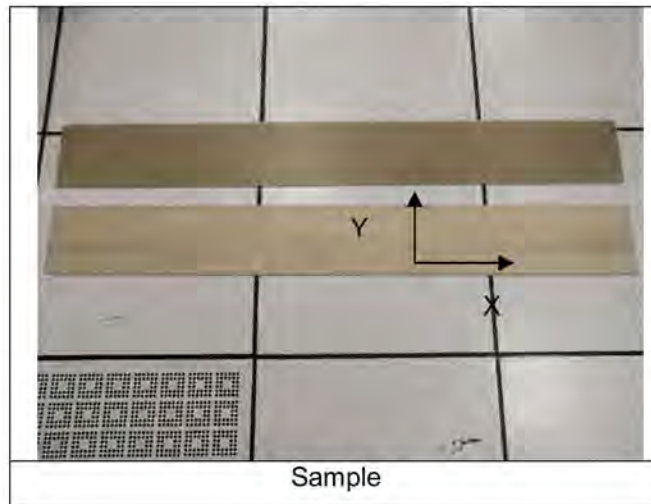
Original Sample Photo:

Note: All test specimens were cut from the samples, see the photographs.
